**COSTA RICA REPUBLIC, CENTRAL AMERICA
NOTICES TO MARINERS**

APRIL 20, 2021
MOPT-04-04-22-008-2021

TUG JOSE MARIA WRECK COORDINATES CHART

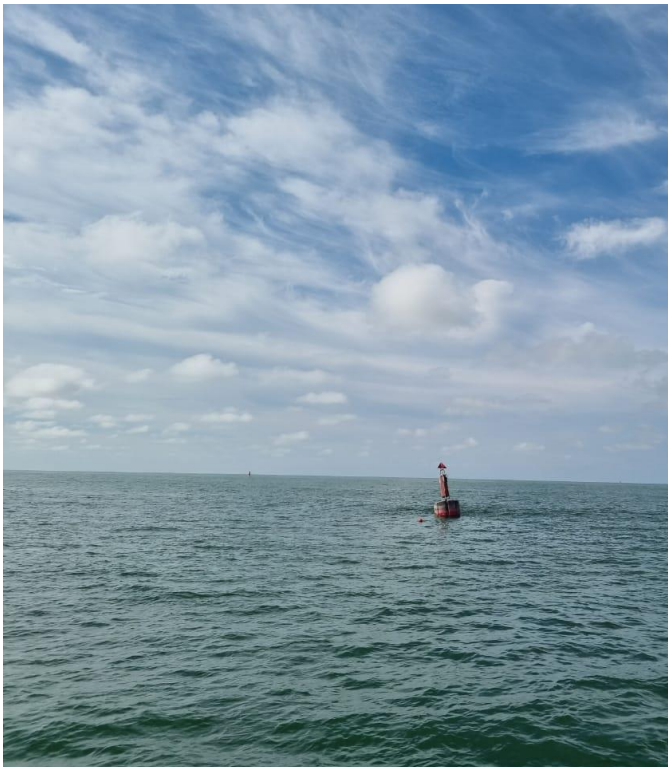
It's communicated to the navigators in general that in the access channel of Port Complex Moín, the sinking of a TUG occurred, which represents a danger to navigation. Has been temporarily demarcated with a later mark (starboard hand –red) in the following coordinates:

10 degrees 01.330 minutes North

83 degrees 04.948 minutes West
